# Irondequoit Public Library System

## Building Conditions Survey January 2005

the  
**Thomas**  
A TETRA TECH COMPANY group

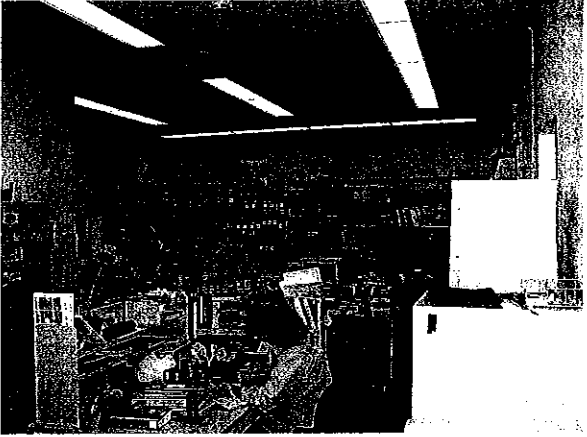
_____ \$	0	1. <b>Stairway Storage:</b> The open design of the stairs encourages storage beneath. Remove stored materials beneath stairs and maintain a no storage policy within the stair tower to comply with code.	
_____ \$	900	2. <b>Safety Glazing:</b> Glazing of panels and doors that extend within 18" of the floor must be of a safety glazing material to reduce the chance of injury due to accidental contact. Reglaze the doors and sidelites at Lower Level Meeting Room with safety glazing.	
_____ \$	0	3. <b>Path of Egress:</b> Remove carts, furniture, displays, etc. to maintain a 5' clear path of egress in vestibules and main aisles and 3'-8" in secondary aisles.

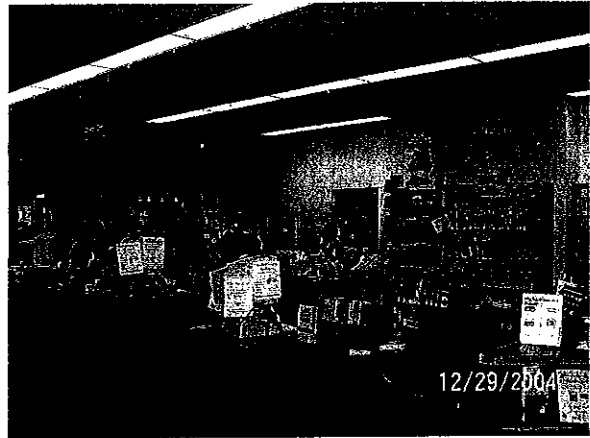
- 22,000 4. **Casework/Furnishings:** The circulation desk and many office work stations are damaged and worn. Cost includes an allowance to replace existing circulation desk and selected workstations and provide additional storage in Workroom.

- a. Size constraints at Circulation Desk and Workroom may require displacement of staff to lower level in order to maintain path of egress noted in Section II above.

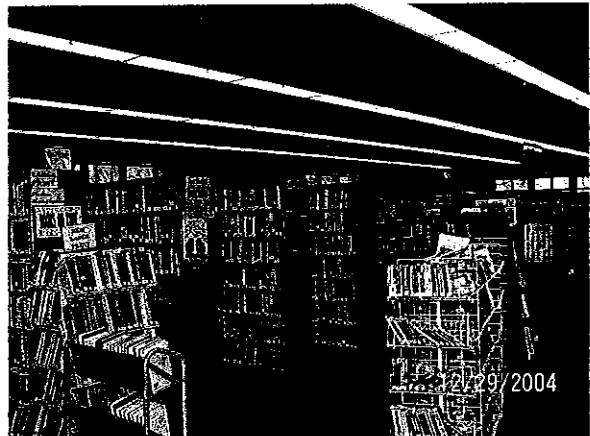
- 31,500 6. **Bookshelves:** Cost includes an allowance to replace selected worn bookshelves in the Reading Areas.

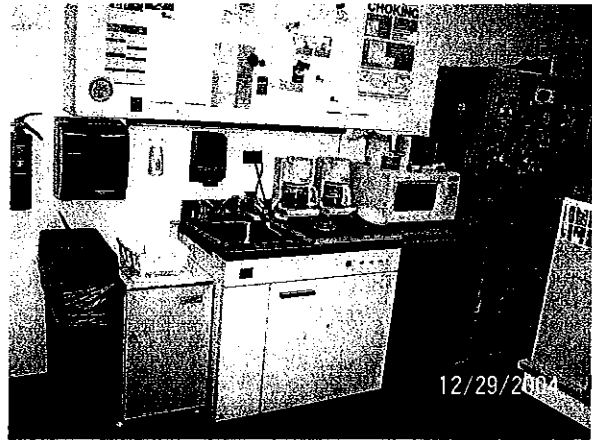
\_\_\_\_\_ \$ 1,800 7. **Kitchenette:**  
 Replace worn base and wall cabinets in Workroom with approx. 6 lf of plastic laminate cabinets / accessible sink.

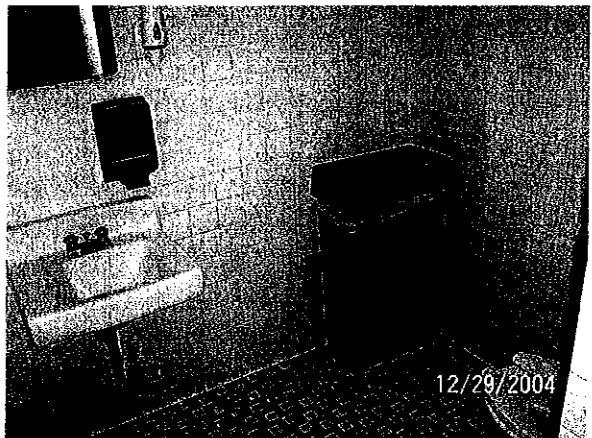
\_\_\_\_\_ \$ 2,200 8. **Ceramic Tile:**  
 Regrout ceramic tile floor and walls in Men's, Women's and Staff Toilet Rooms and Custodial Closet of original building; miscellaneous patching required.

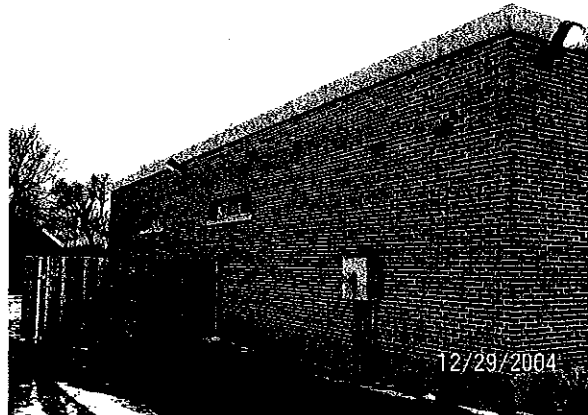
- \_\_\_\_\_ \$ 15,000 17. **Brick/Stonework:**  
Minor brick and stone restoration is required. Repoint brick and joints in stone where necessary. Minor stone / precast patching and brick cleaning required.

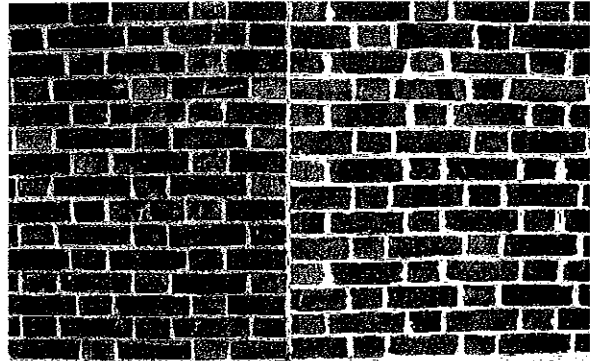
\_\_\_\_\_ \$ 900 19. **Sealant - Joints:** Sealant in building expansion joints have dried and become brittle or split. Replace sealant.

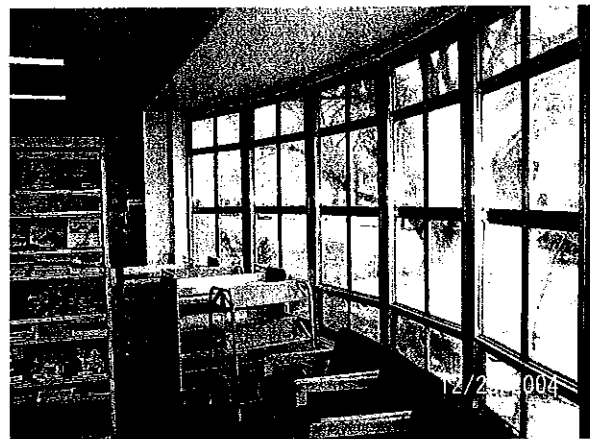
\_\_\_\_\_ \$ 26,500 2. **Windows:** Existing windows provide poor thermal and air resistance. Exterior window sealant has weathered and cracked or split. Replace all single glazed windows (including bay window in front of building) with new thermally broken dual glazed aluminum framed system to improve energy efficiency and appearance. Cost also includes allowance for new blinds or shades of type to be determined.
