Irondequoit Public Library System

Building Conditions Survey January 2005

the
Thomas
A TETRA TECH COMPANY group

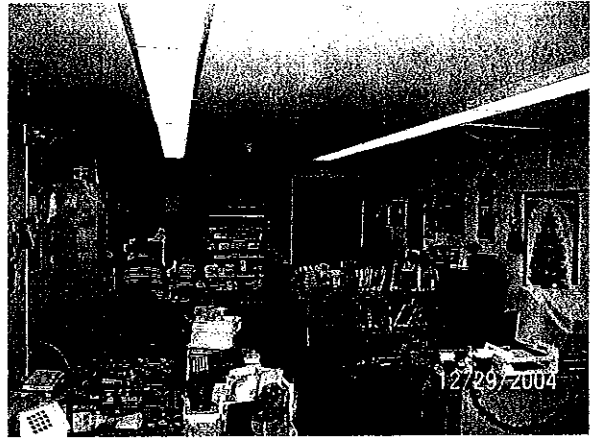
_____ \$ 100 5. **Path of Egress - Lower Level:** Doors in a path of egress should generally swing in the direction of travel; remove the door between the Workroom and Storage Room.

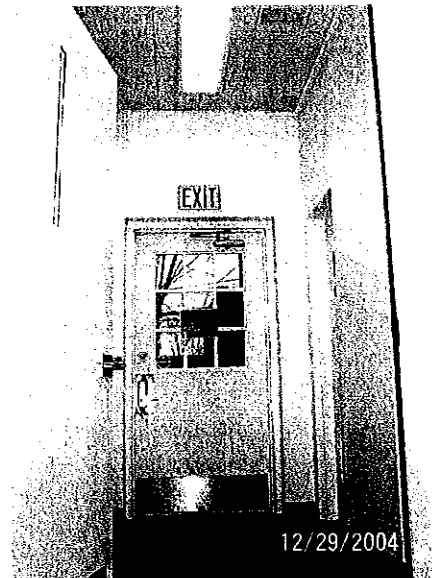
_____ \$ 1,950 6. **Door Hardware:** Provide fire exit hardware (panic bars) at ramp into Lower Level Storage Room, north exit door from Reading Room and North exterior door.

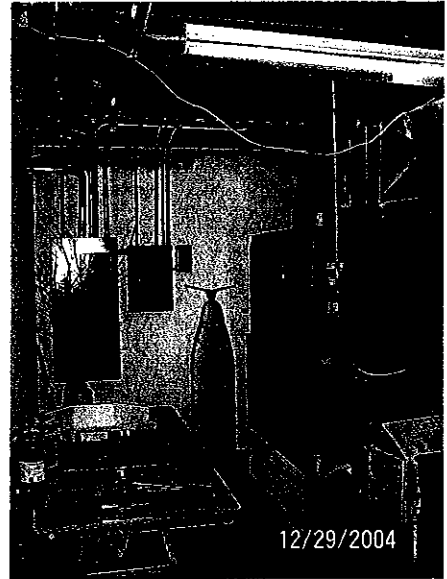
- 2,200 7. **Mechanical Room Enclosure:**
Provide rated enclosure with
labeled door between
mechanical equipment and
Lower Level Playroom.

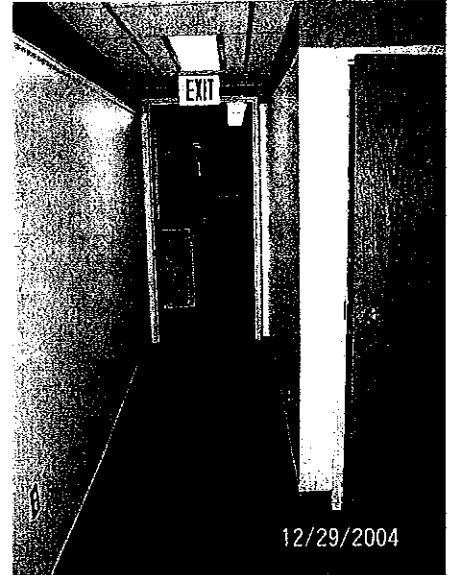
- 400 8. **Railings:** Provide hand railing at
lower level ramp.

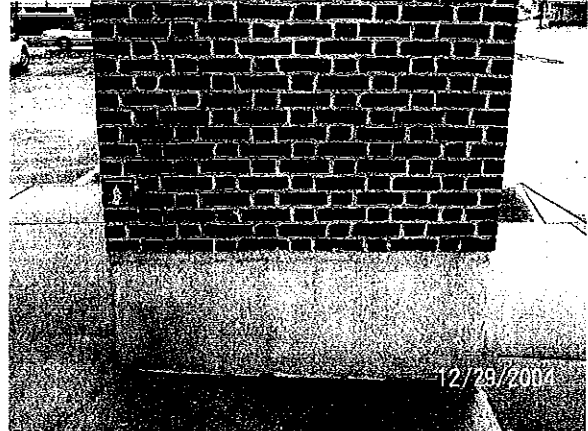
_____	\$	1,400	1.	Entry Columns: Replace damaged EIFS bases; provide expansion joint between bottom edge and adjacent concrete sidewalk.
-------	----	-------	----	---

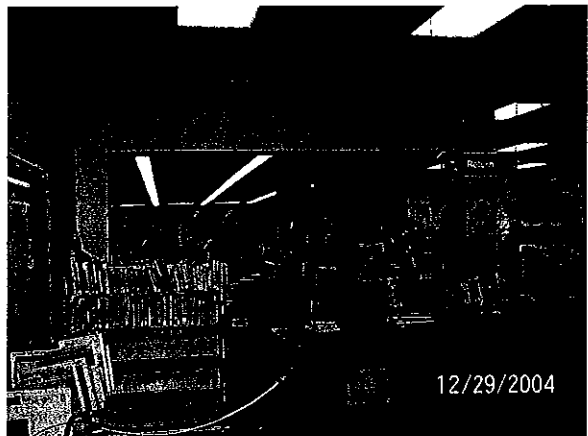
_____	\$	28,500	3.	Casework/Furnishings: The circulation desk and many office work stations are damaged and worn. Cost includes an allowance to replace existing circulation desk and selected workstations and provide additional storage in Workroom.
-------	----	--------	----	---

- a. Size constraints at Circulation Desk and Workroom may require displacement of staff to lower level in order to maintain path of egress noted in Section II above.

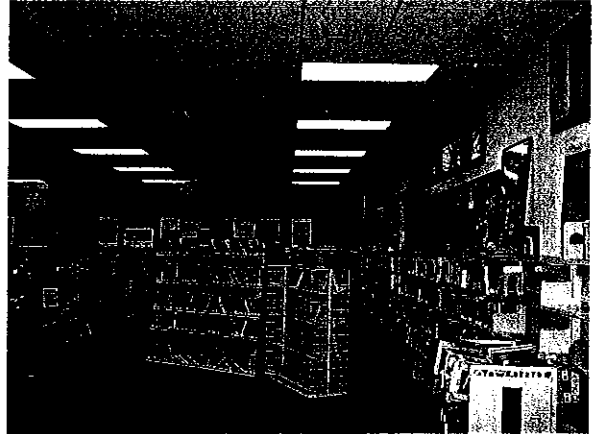
_____ \$ 31,500 5. **Bookshelves:** Cost includes an allowance to replace selected worn bookshelves in the Reading Areas.

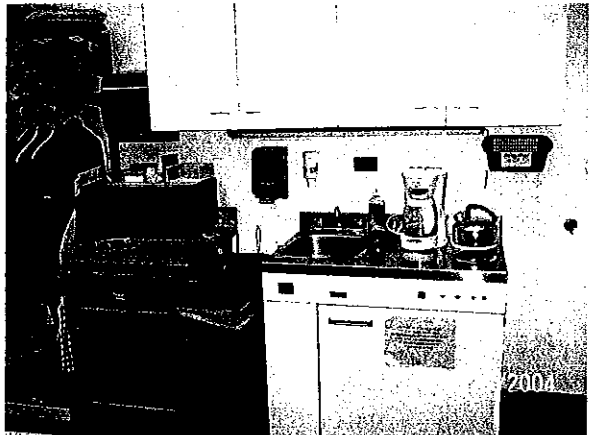
_____ \$ 1,800 6. **Kitchenette:** Replace worn base and wall cabinets in Workroom with approx. 6 lf of plastic laminate cabinets / accessible sink.

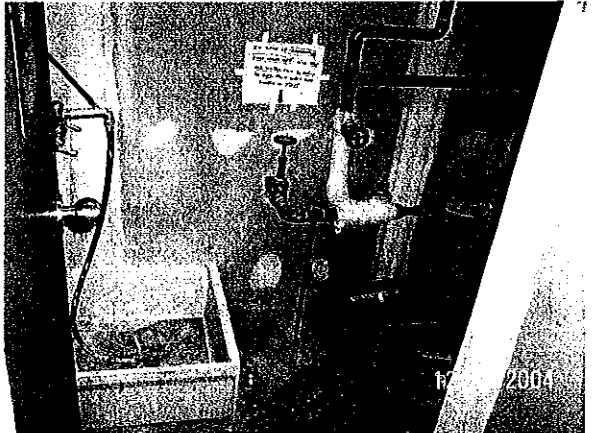
_____ \$ 500 7. **Custodial Closet – Lower Level:** Provide lexan or acrylic panels to wall surfaces adjacent to mop sink. Add door closer; seal concrete floor.

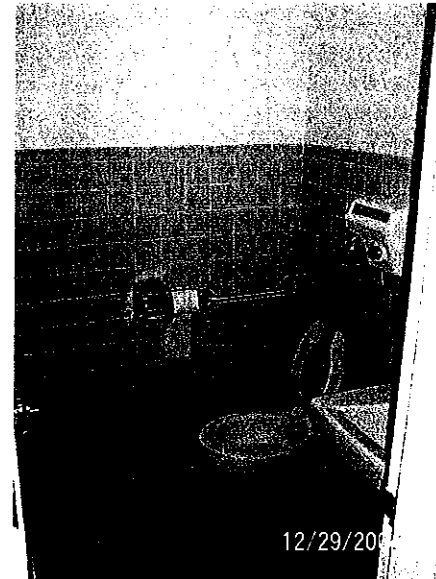
_____ \$ 2,200 8. **Ceramic Tile:** Regrout ceramic tile floor and walls in Men's, Women's and Staff Toilet Rooms and Custodial Closet of original building; miscellaneous patching required.

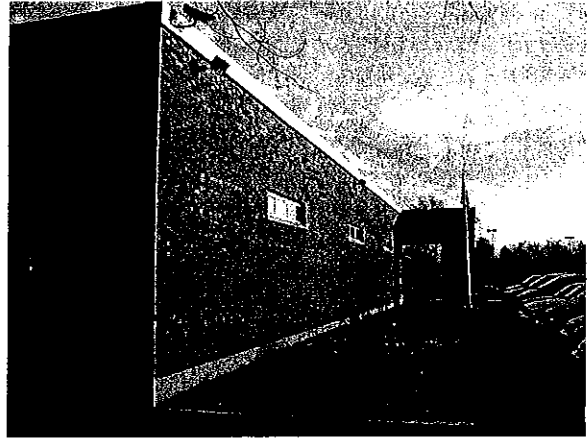
_____ \$ 12,000 14. **Brick/Stonework:**
 Minor brick and stone restoration is required. Repoint brick and joints in stone where necessary. Minor stone / precast patching and brick cleaning required.
